Technical Assessment of the Transette Transit System

Transportation Systems Center
Cambridge MA 02142

October 1981
Final Report

U.S. Department of Transportation
**Urban Mass Transportation
Administration**

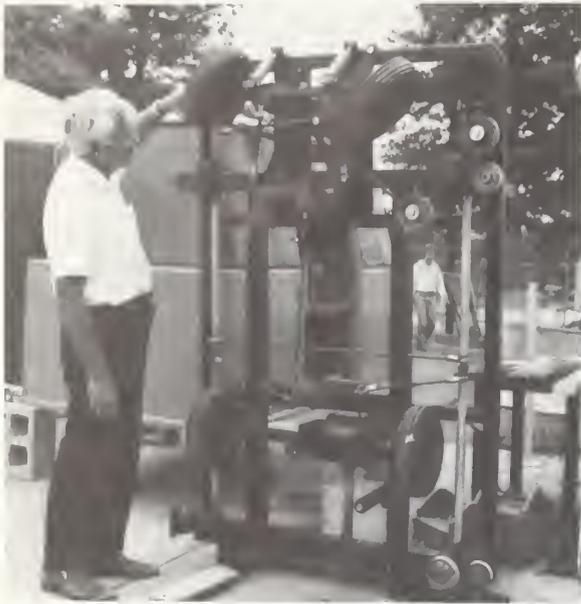
FIGURE 3-4. TWO VIEWS AND A SCHEMATIC OF THE STEERING AND SWITCHING GEAR

Switching to the off-line station is achieved by movement of a guideway-mounted blade that trips a vehicle-mounted cam that in turn causes the steering control to be transferred from the left side of the vehicle to the right. The switched wheels contact the right hand guideway mounted steering rail which directs the vehicle off-line and into the station. The guideway mounted blade is solenoid actuated and is controlled from the control house.

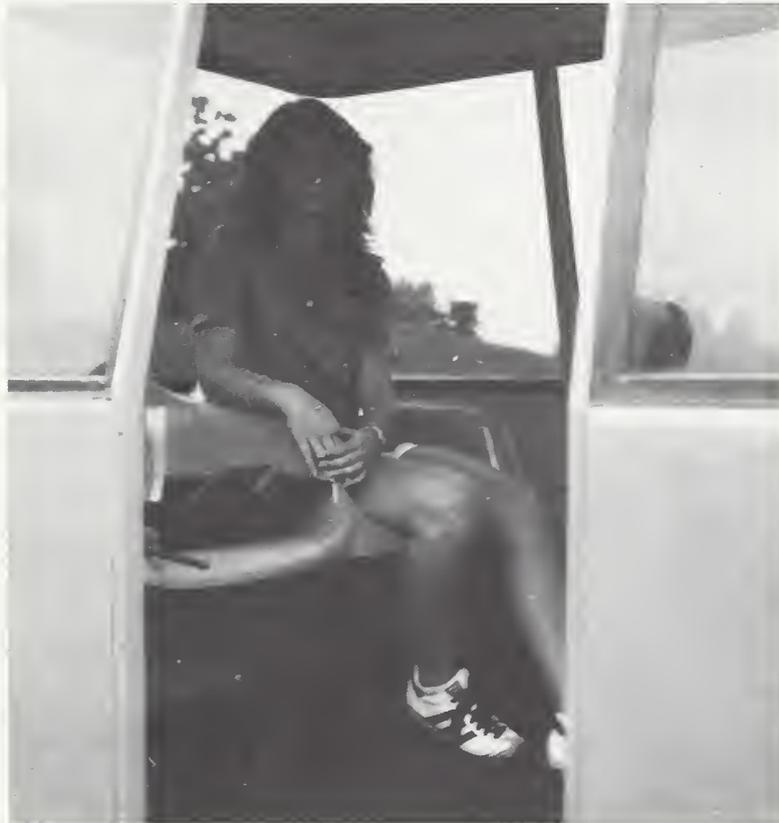
FIGURE 3-5. VIEW OF THE VEHICLE INTERIOR

The interior of the vehicle with a seated passenger is shown in Figure 3-5. A schematic of the vehicle is shown in Figure 3-6.

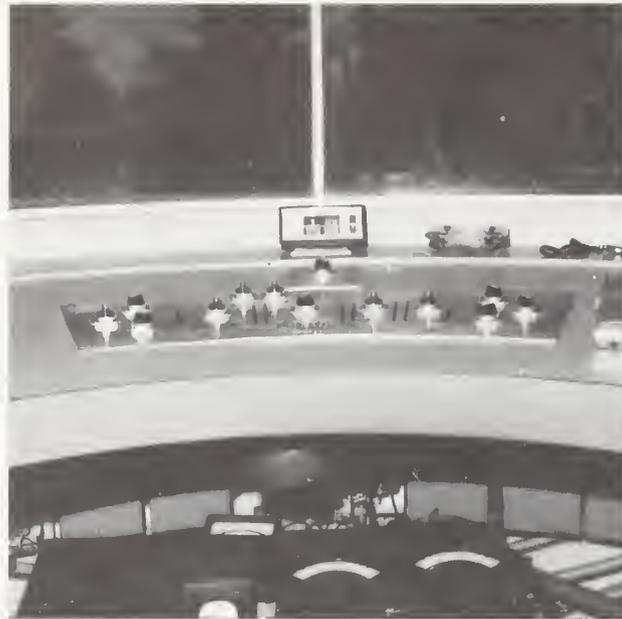
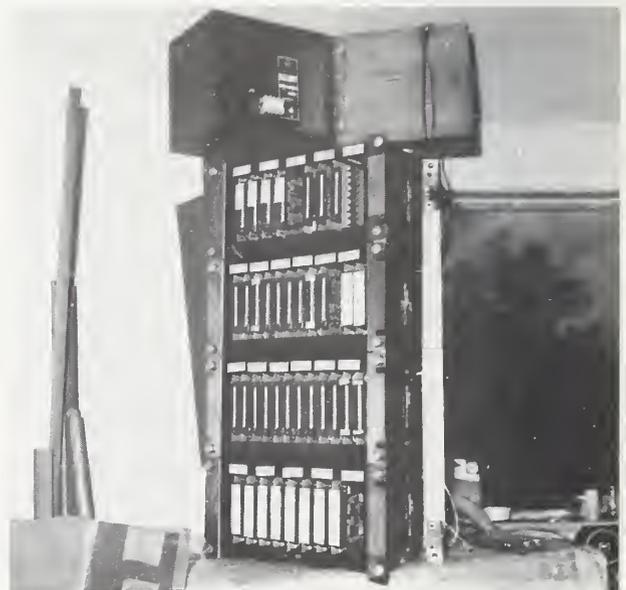
CONTROL PANEL

REAR VIEW OF SOLID STATE
CONTROL SYSTEM

SOLID STATE CONTROL SYSTEM

FIGURE 3-12. THE CONTROL STATION AND SOME OF THE EQUIPMENT
